How To Repair Dim Display Problem in LG 19" LCD Monitor

The LG 19" LCD Monitor Details

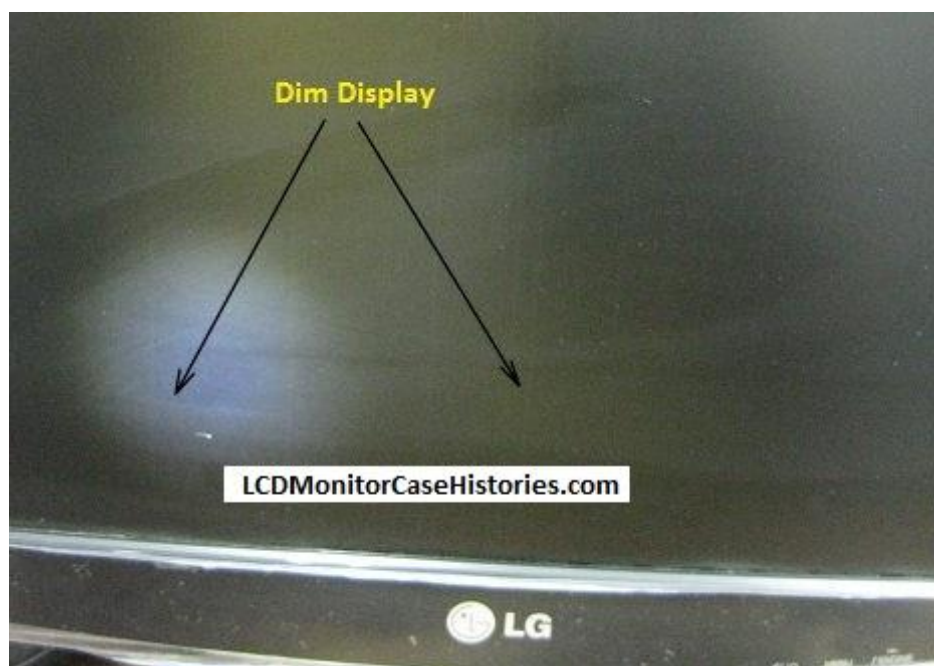
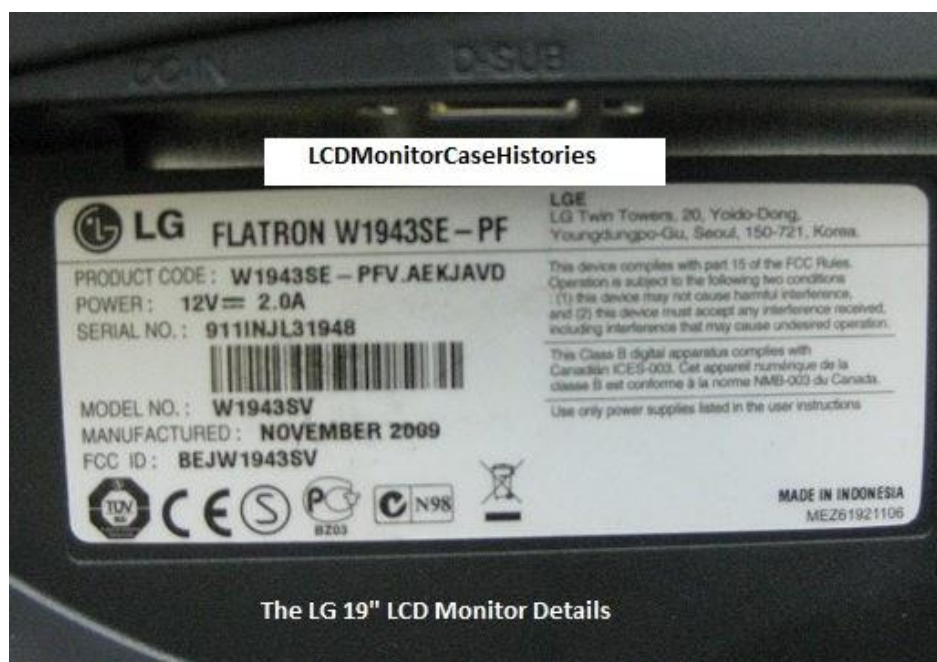
The complaint of this monitor was dark display but careful inspection with a bright torch light; you could see a very faint picture (dim display). Dim display problem is usually in the inverter board section and not due to bad backlight. If the monitor have display for few seconds and then shut down, you can suspect the backlight and the inverter section.

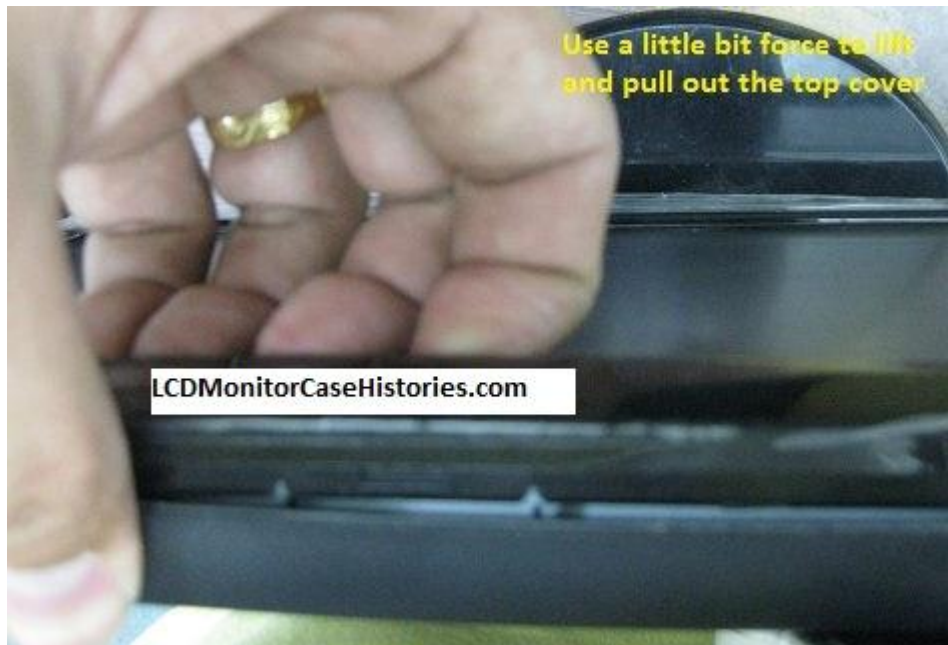
This monitor does not have screws at the back because the cover was using internal clips. In order to open this kind of cover, you need to apply some force to gently lift and pull out the cover (please see the photo).

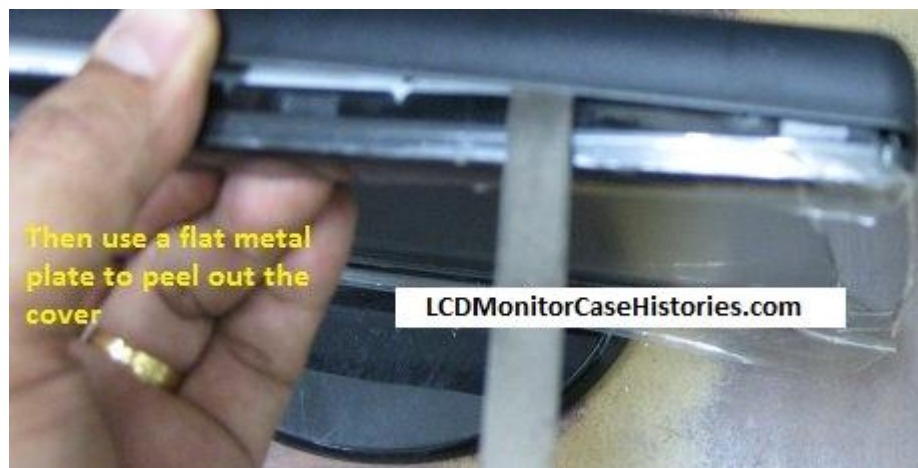
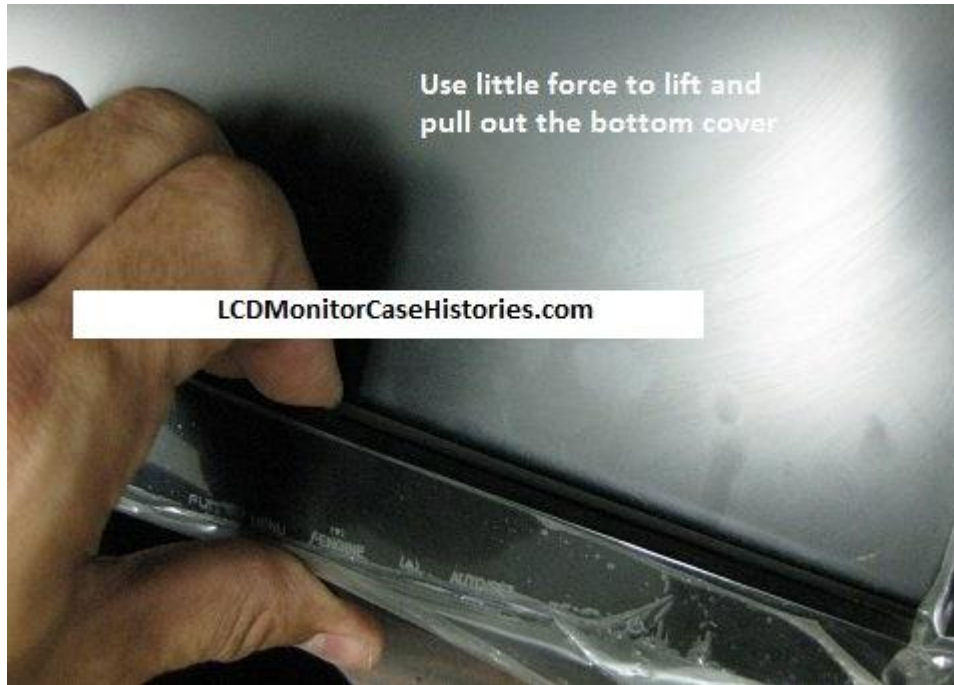
I started to remove the cover from the top (in other models you can start from the bottom cover) and once opened you can start to peel out the side cover with a flat metal plate-see the photo below.

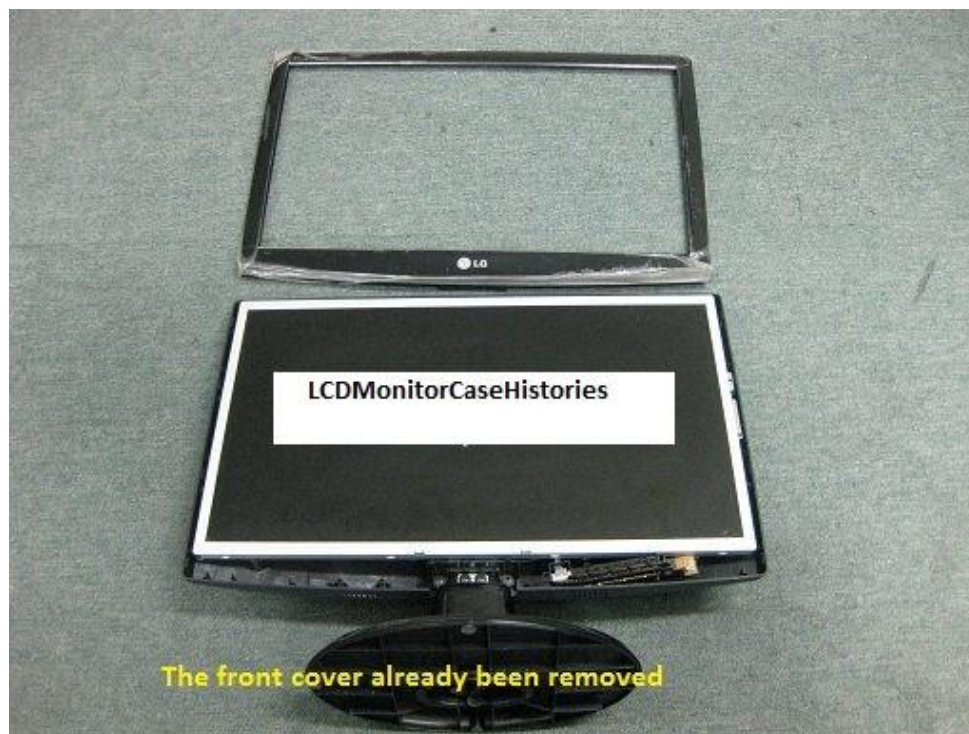
Once the side cover already opened, removing the whole cover would be very easy.

Now you could see the LCD panel. For your information this monitor does not use screws to tighten the shielding and the circuit board. The whole board just drops off once the LCD panel is removed.

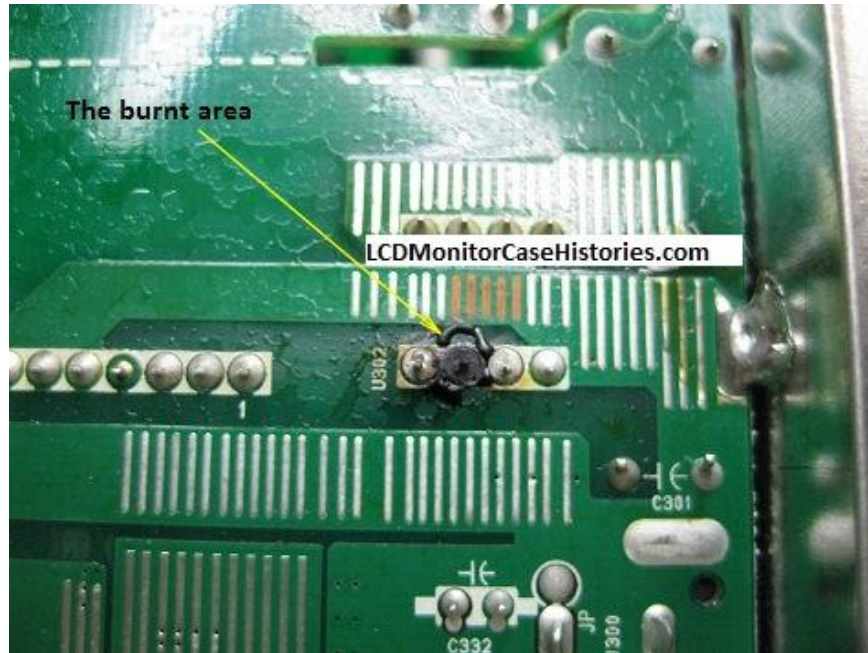
From behind the board I could see a burnt mark in one of the 8 pins of the dual inline IC.

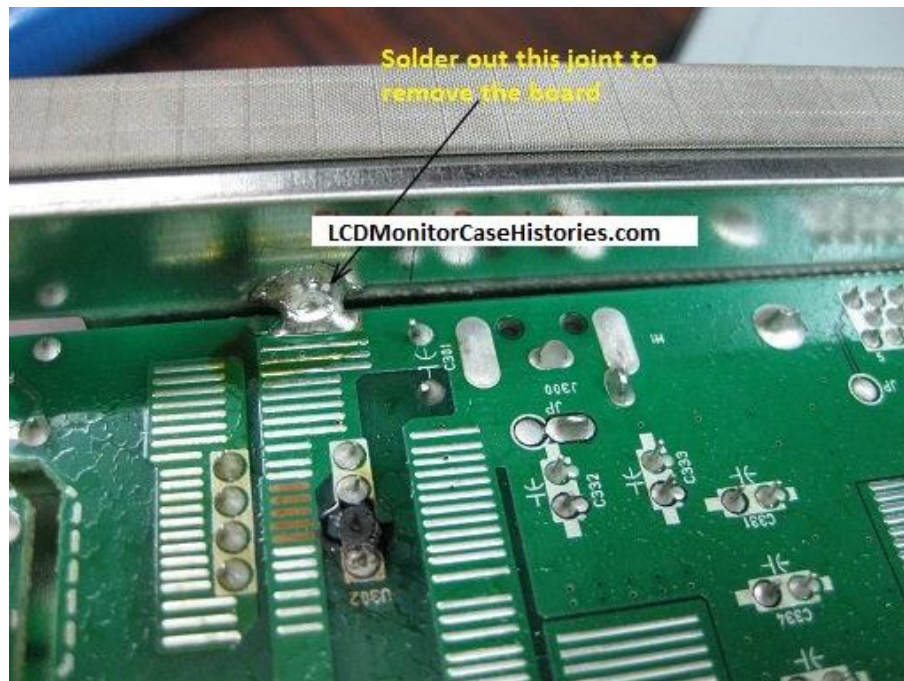
There was only one soldering spot that you need to desolder in order to remove the whole board from the shielding.

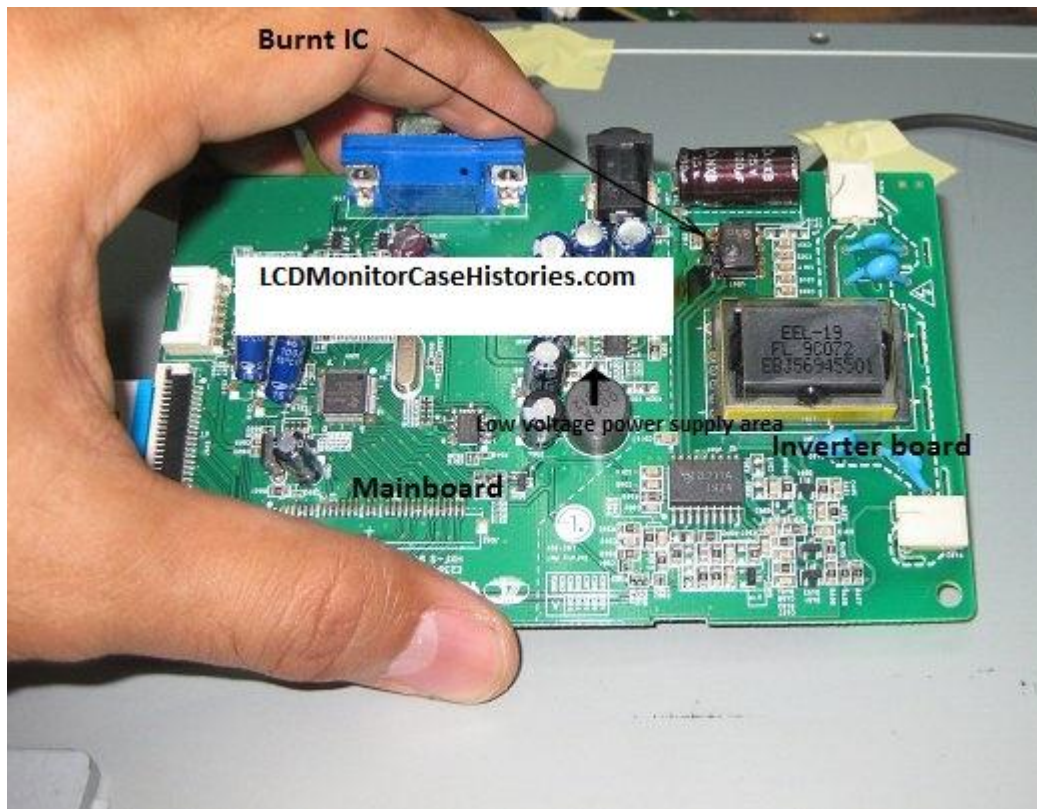
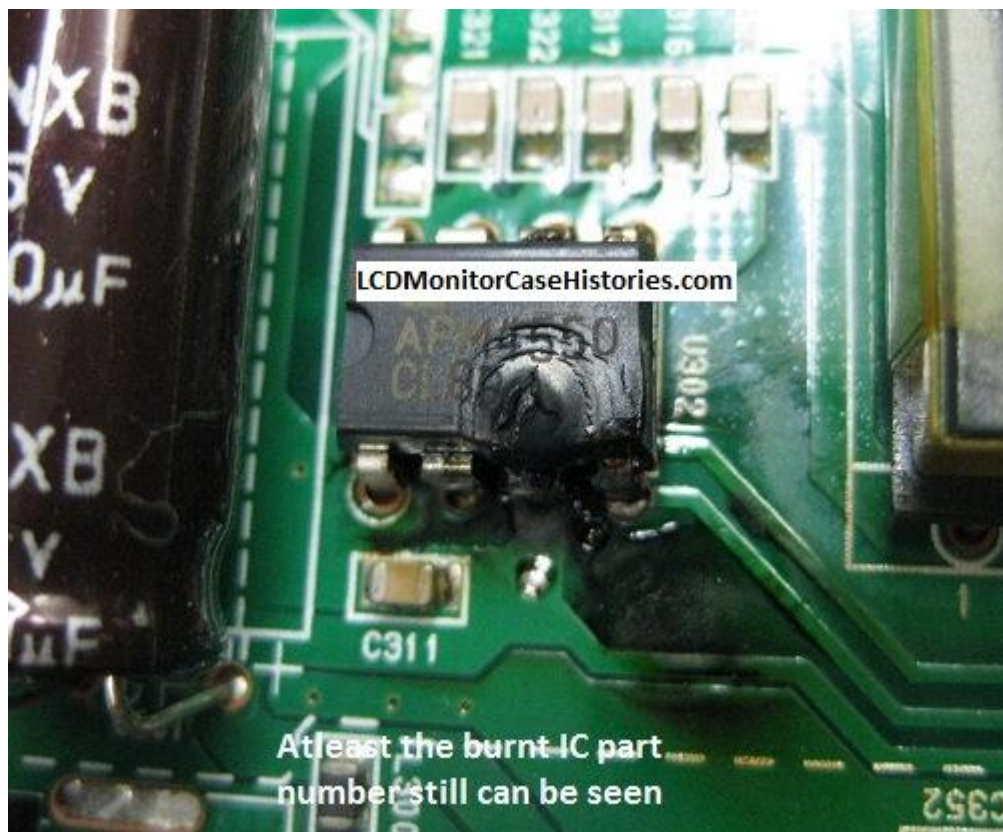
Once the board was removed I could clearly see the burnt IC but fortunately the part number still can be seen and it was APM4550 (Dual Enhancement Mode Mosfet N and P-Channel).

After done the research I concluded that I have to use another part number with slightly different spec because my side here does not have such part number. The part number that I have chosen for the substitution was 4051GSD or **AP4051GSD**. This part number was taken from ACER AL1717 junk board. **It is always good to keep some junk boards so that you can salvage the parts.**

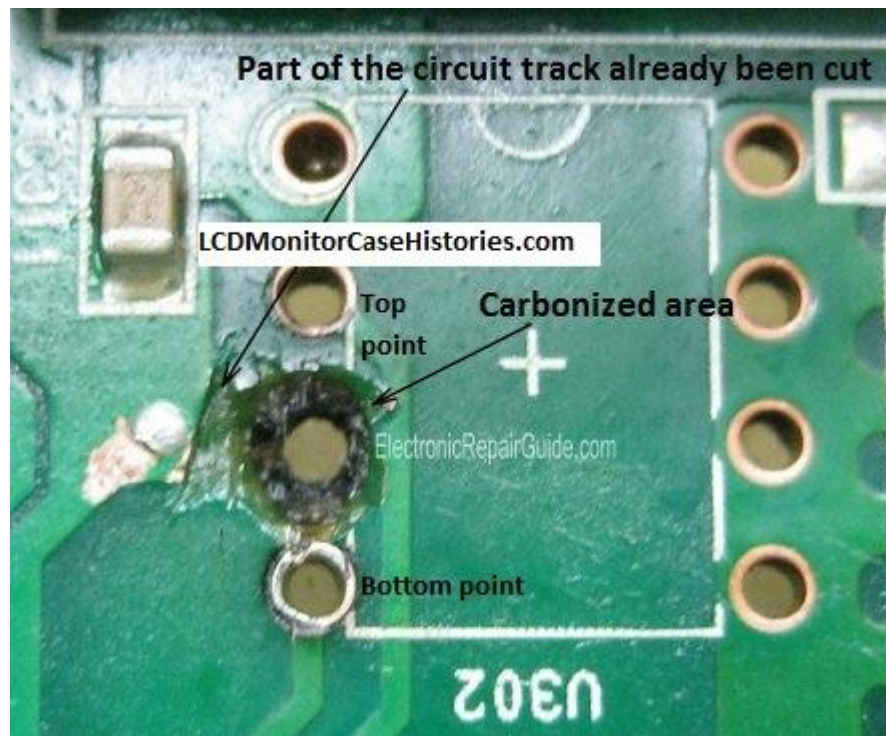
Once the burnt IC removed, I cleaned it with thinner and make sure there is no circuit track broken. In order to prevent the replacement IC from burning again due to the carbonized area (carbonized board can become conductive), I have to cut away one small part of the circuit track as seen from the photo in the next page.

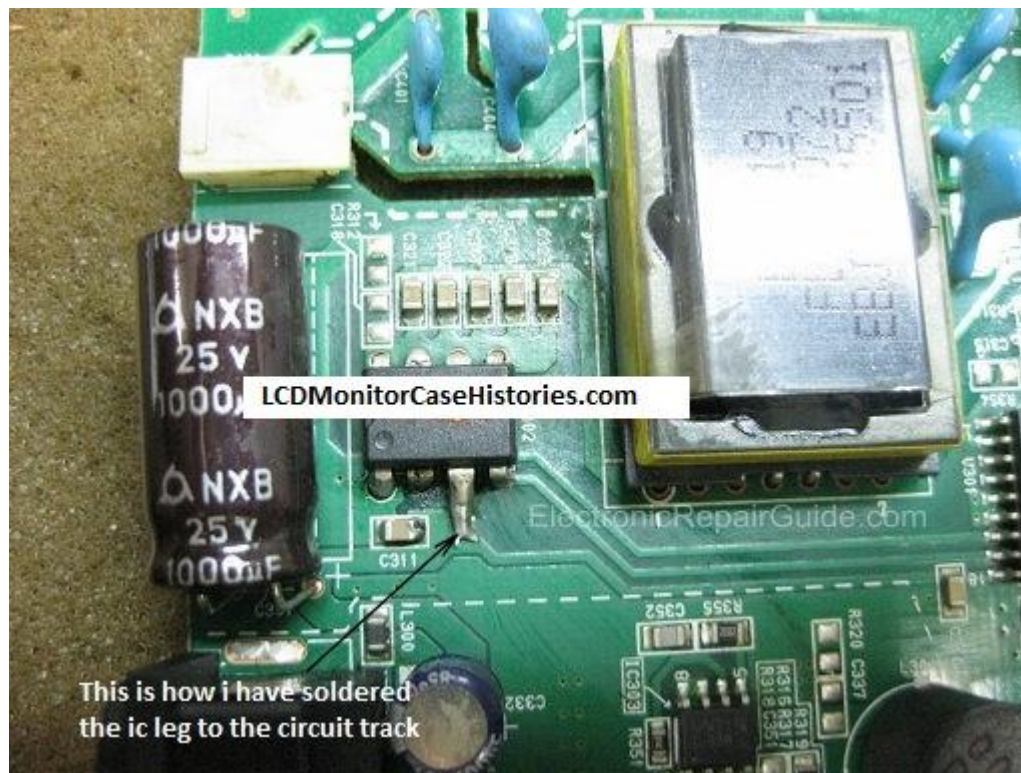
Then I put in the replacement IC and have spent another couple of minutes to check and make sure all components are in order before turning on the set.

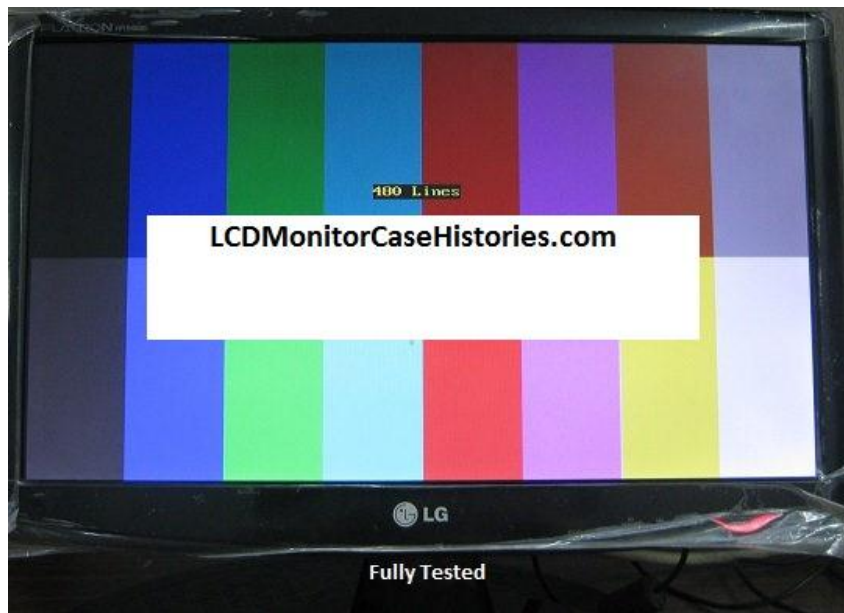
I powered it on and saw a clear LG logo and I was very happy. The replacement IC was a bit warm and not hot. I let the set run for couple of days and it worked beautifully.
